ISSUE DATE; 1--91 MODEL: 9C
 REVISION DATE: -- 12C

SUBJECT: **Battery Charging Rectifier Terminals B1 & B2 Burnt** NO.: 509

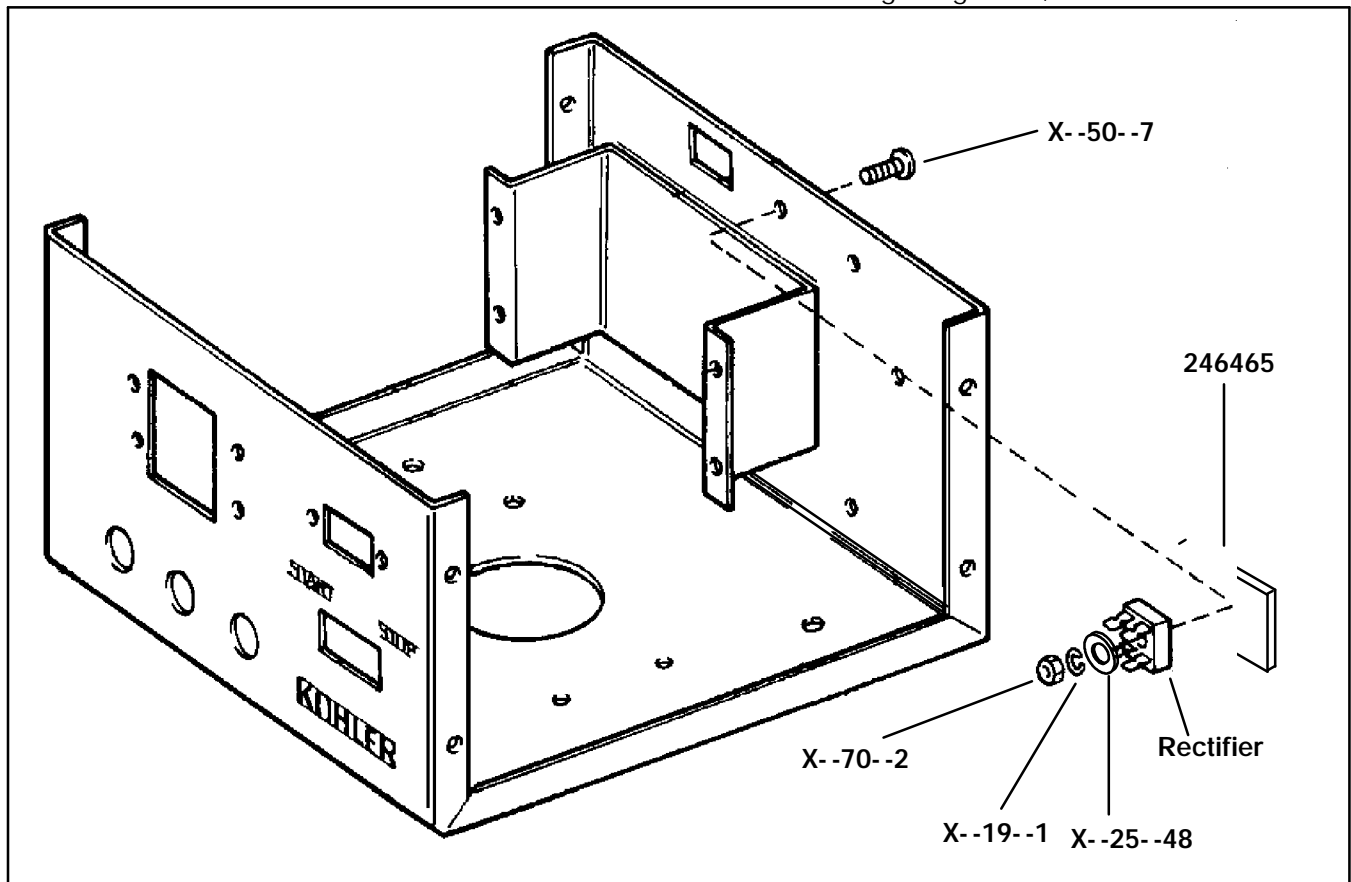
High ambient temperatures, coupled with high battery charging rates and poor heat dissipation between the battery charging rectifier (239651) and controller, has lead to burnt B1 and B2 terminals, in some cases.

Using a heat sink (246465 shown below) to improve rectifier cooling will help eliminate problems with burnt terminals and leads.

Mount heat sink between rectifier and controller box as shown below.

Note: Thermal transfer compound must be applied to back of rectifier before mounting to heat sink.
